Restoring the Sanctuary of Our Lady of Mercy, Qrendi

A project like no other

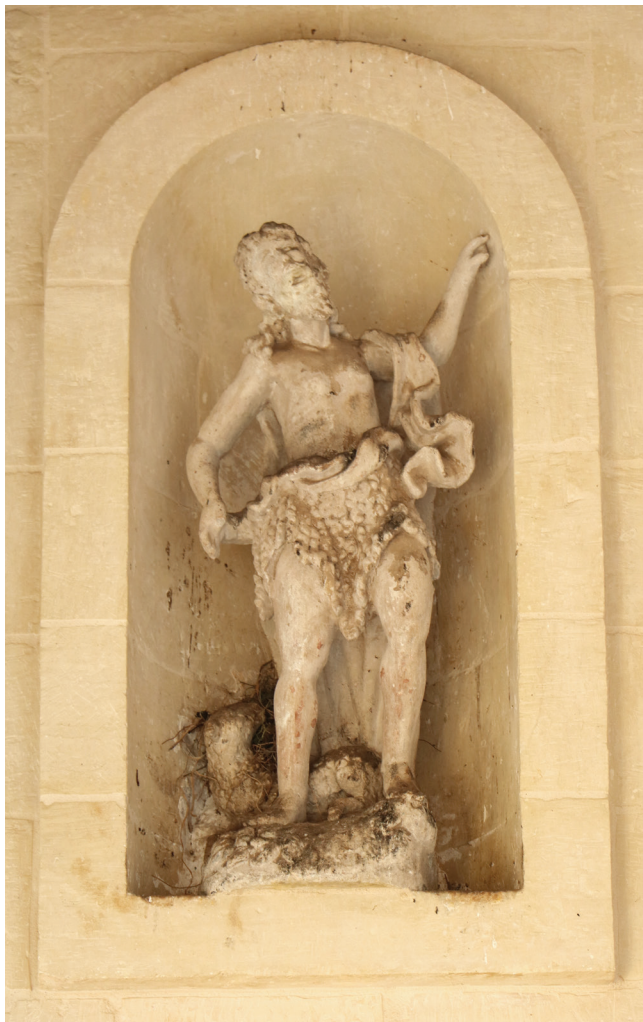
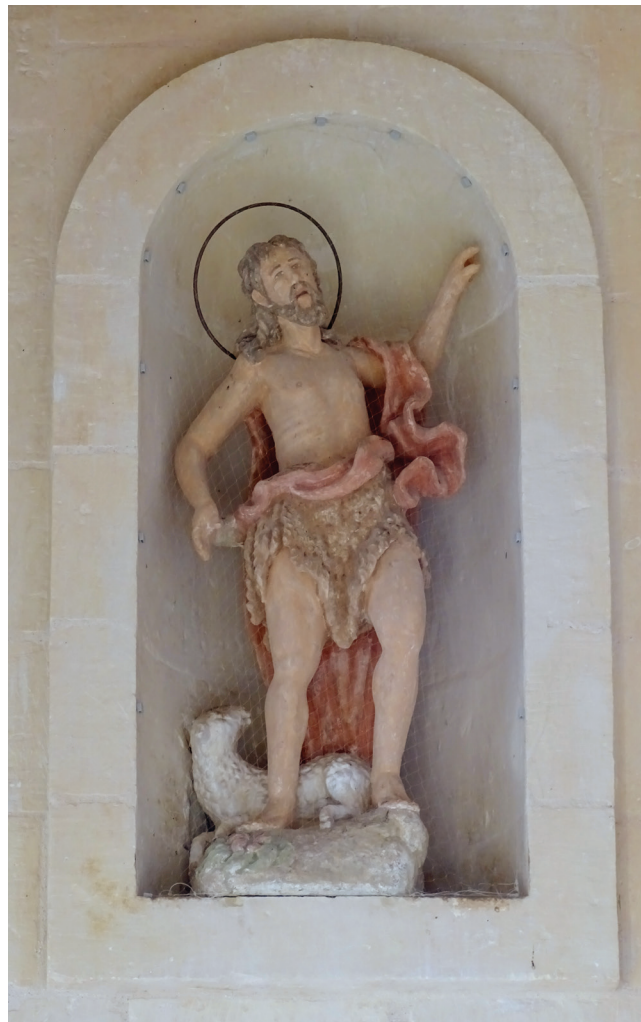
Fig. 4
Stone statue of St John the Baptist on the external façade, before restoration.
(Photo: Restoration and Preservation Department, Malta)

Fig. 5
Stone statue of St John the Baptist on the external façade, after restoration.
(Photo: Restoration and Preservation Department, Malta)

When cleaning started on the delicate statues (Figs 4-5) and the coat of arms on the portico, traces of original coloured lime renders were revealed, serving as a prelude of what was to be found later in the interior of the church. After cleaning, powdering areas were consolidated

and lime-based colour renders were applied in a semi-transparent *velatura* effect.

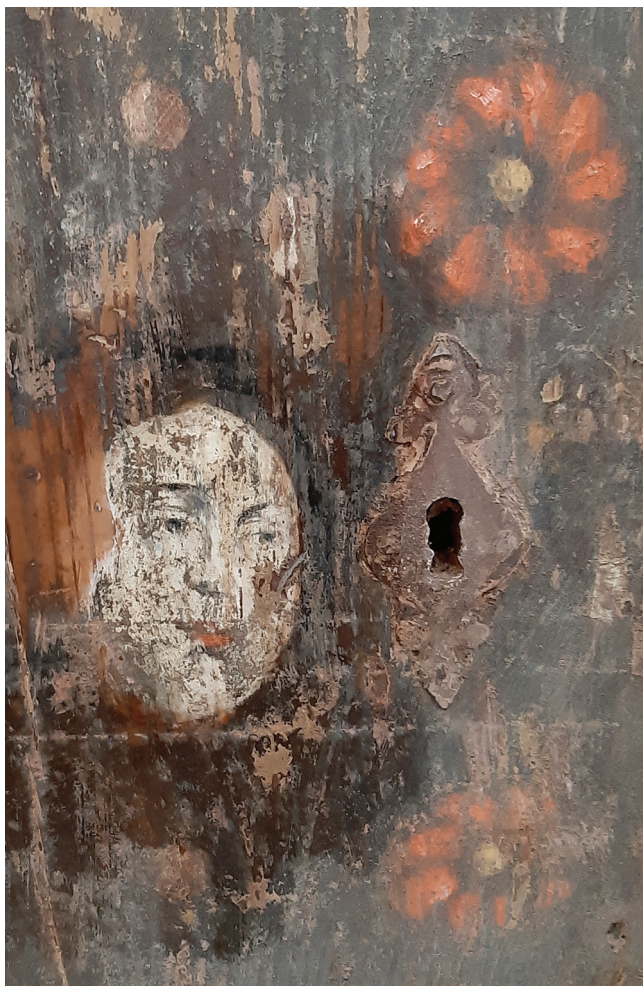
Fig. 7
Facial and floral motifs uncovered on the sacristy door during restoration.
(Photo: Restoration and Preservation Department, Malta)

Another fortunate finding was the decorative art, depicting floral and face motifs, painted directly onto the timber of the sacristy door (Fig. 7). As the restoration works to the apertures were in full swing, which besides disinfestation and localised replacements involved paint removal, the unexpected face—later rumoured to belong to one of the church’s benefactors, Fra’ Philipp-Wolfgang von Guttenberg⁹—revealed itself to the craftsman restoring it. This prompted, yet again, more scientific investigations which suggested that the paintings date to before the nineteenth century.

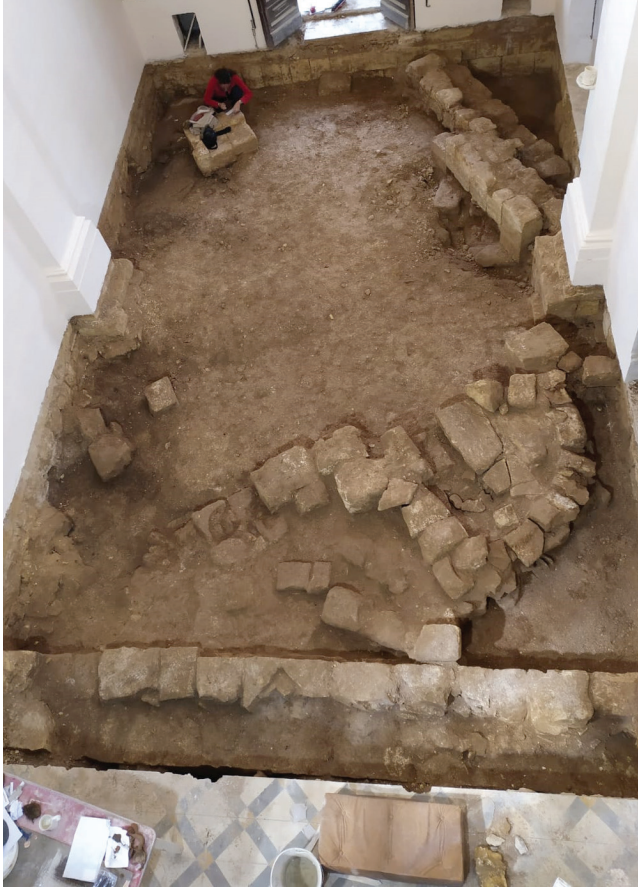
Fig. 8
Archaeological remains of the foundations of the earlier medieval church were unearthed during the restoration works. The discovery showed that the present-day church has a different orientation from that of the earlier one. (Photo: Restoration and Preservation Department, Malta)

The church’s final disclosure, at least within the framework of this restoration project, came during the restoration of the rest of the floor, in the main space of the nave. From the outset, it was known that this church was built on the foundations of another, but when the existing and heavily damaged cement tile floor started to be lifted off and the underlying debris cleaned up, the traceable outline of the medieval chapel revealed that it had a completely different orientation to that of the present-day church.

An archaeological dig ensued, the perimeter of the mediaeval church was unearthed (Fig. 8), the remains consolidated and fully documented with 3D-laser scanning, for the first time recording the shape, form, and orientation that this medieval chapel had. A geotextile was then inserted, the area was backfilled, and the new floor was laid above where the old and degraded cement tiles were replaced with new copies carrying the same pattern and colour scheme, but with a new addition. The medieval church perimeter below was now outlined in deep red and incorporated into the new patterned cement tiles above, visibly linking these two churches for the very first time.
